Exterior Architectural Finishes in Puerto Rico: The Painting Traditions of Guayama's Vernacular Architecture

Betty L. Prime
University of Pennsylvania

Prime, Betty L., "Exterior Architectural Finishes in Puerto Rico: The Painting Traditions of Guayama's Vernacular Architecture" (2011). *Theses (Historic Preservation)*. 164.
http://repository.upenn.edu/hp_theses/164

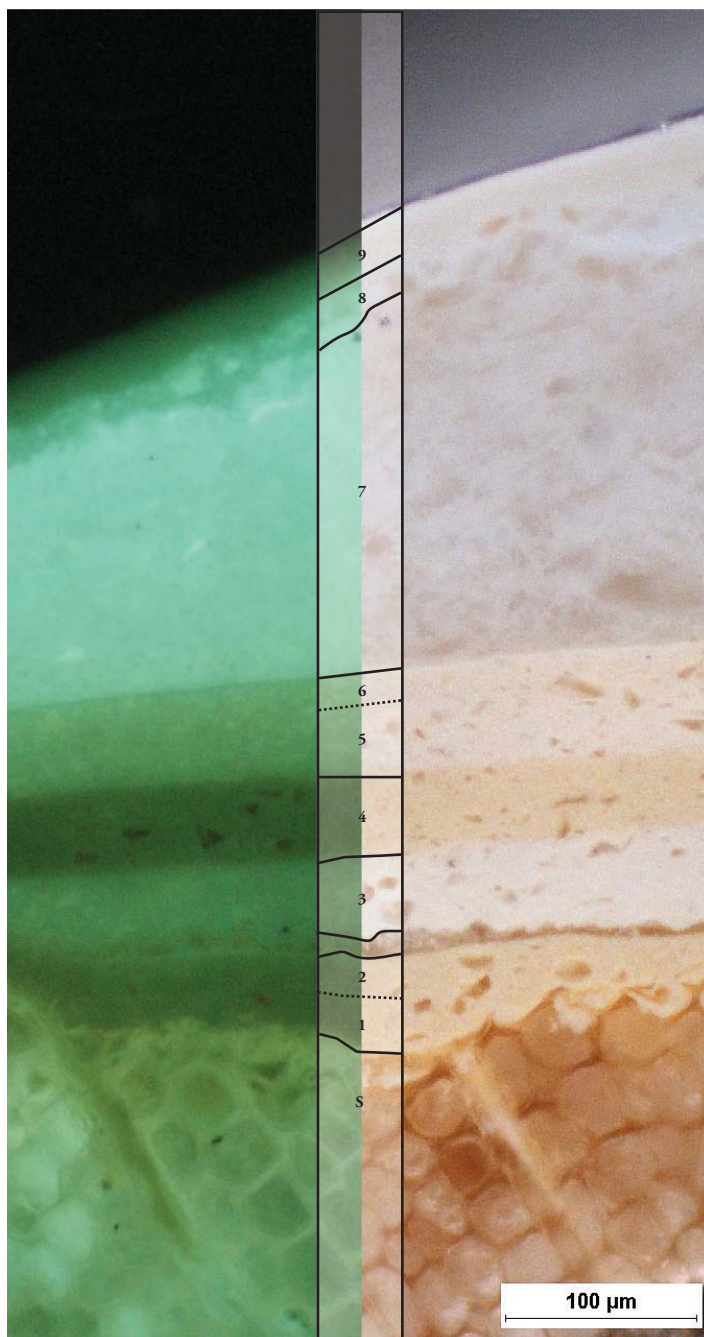
Guayama, Puerto Rico
6 E. Cecelio Dominguez Street

Sample Number: 6 :A: 2	Element: wall	Date Sampled: 02/13/11
Sample Location: trim board at wall		Date Analyzed: 04/09/11
Substrate: wood	Illumination: Fluorescence BV 1A, Reflected/Quartz Halogen	
Microscope: Nikon ALPHAPHOT2-YS2		Objective: 10x
Analysis Performed by: Betty Prime		Camera: Nikon DS-Fi1

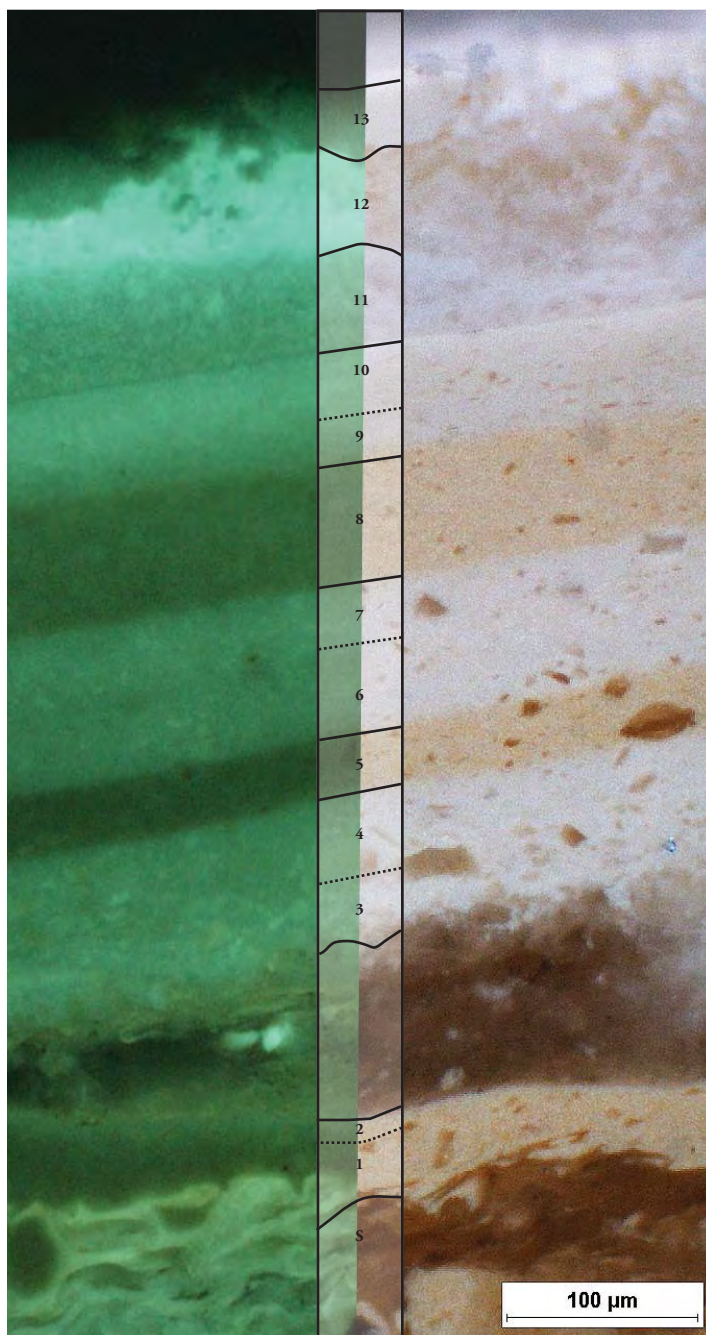
Guayama, Puerto Rico
6 E. Cecelio Dominguez Street

Sample Number: 6 :A: 3	Element: wall	Date Sampled: 02/13/11
Sample Location: baseboard		Date Analyzed: 04/09/11
Substrate: wood	Illumination: Fluorescence BV 1A, Reflected/Quartz Halogen	
Microscope: Nikon ALPHAPHOT2-YS2		Objective: 10x
Analysis Performed by: Betty Prime		Camera: Nikon DS-Fi1

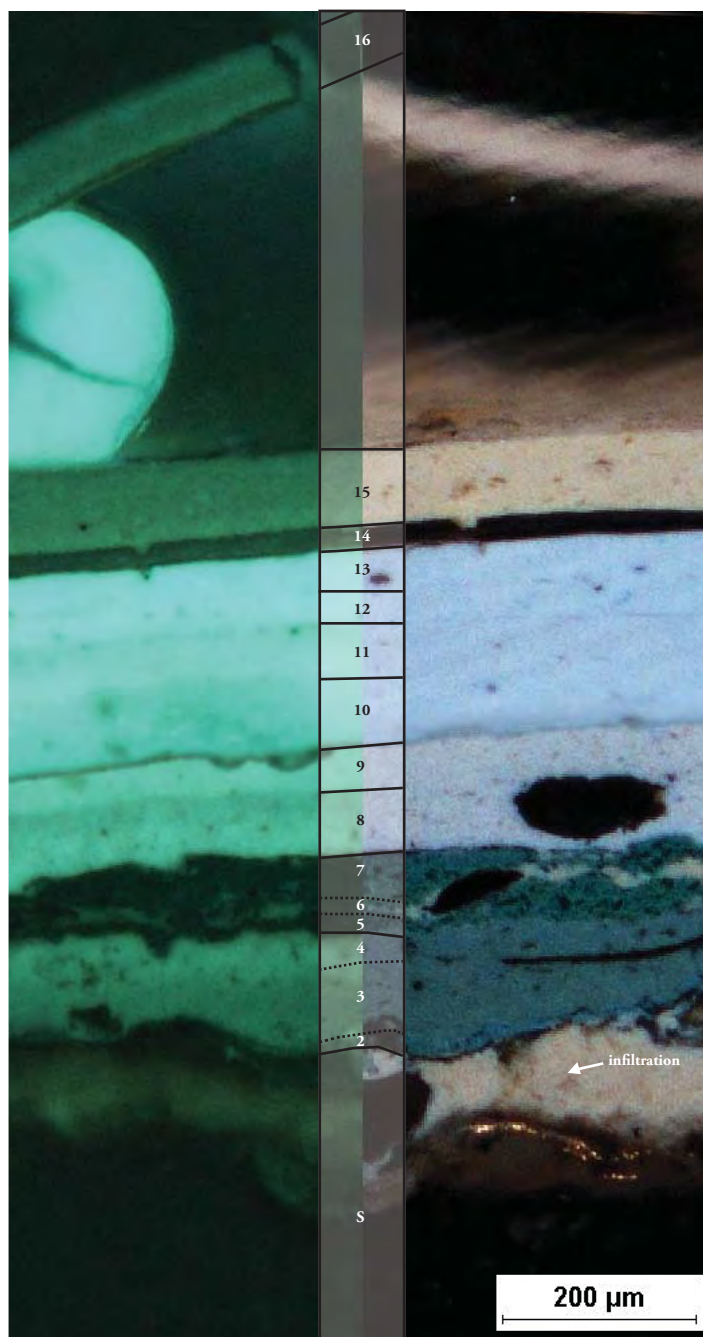
Guayama, Puerto Rico
6 E. Cecelio Dominguez Street

Sample Number: 6 :B: 2	Element: building base	Date Sampled: 02/13/11
Sample Location: right hand corner of frosting		Date Analyzed: 04/09/11
Substrate: wood	Illumination: Fluorescence BV 1A, Reflected/Quartz Halogen	
Microscope: Nikon ALPHAPHOT2-YS2		Objective: 4x
Analysis Performed by: Betty Prime		Camera: Nikon DS-Fi1

Scheme/Layer		Color
10	14	yellow
9	13	*yellow
8	12	dark brown
7	11	*light blue
6	10	light blue
5	9	*light blue
4	8	light blue
3	7	/light grey white
2	6	light grey white
	5	/*dark green
	4	yellow tan
1	3	green
	2	green
	1	blue green
		substrate

Color: F1: green
Munsell Color F1: 5G 7/8 - 5G 7/6
Probable Medium: oil
Comments: not for color matching,
yellow infiltration near the substrate

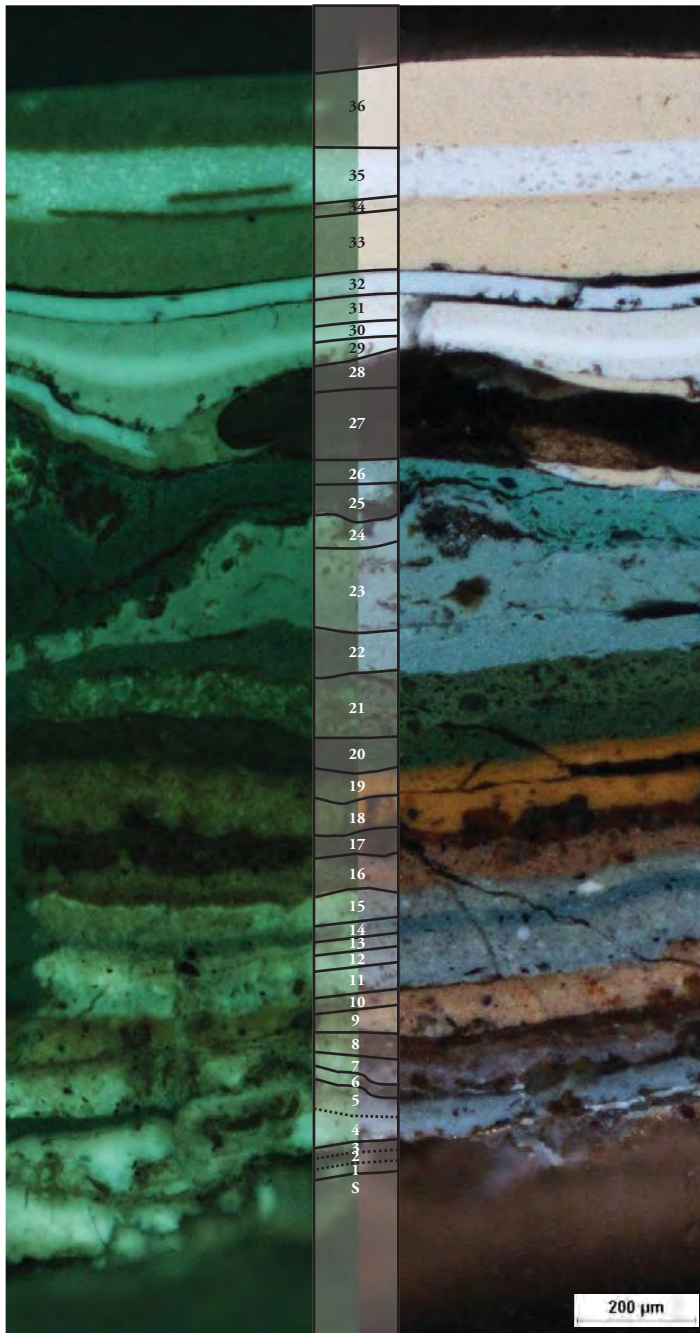
Guayama, Puerto Rico
6 E. Cecelio Dominguez Street

Sample Number: 6 :B: 4	Element: building base	Date Sampled: 02/13/11
Sample Location: middle panel		Date Analyzed: 04/09/11
Substrate: wood	Illumination: Fluorescence BV 1A, Reflected/Quartz Halogen	
Microscope: Nikon ALPHAPHOT2-YS2		Objective: 4x
Analysis Performed by: Betty Prime		Camera: Nikon DS-Fi1

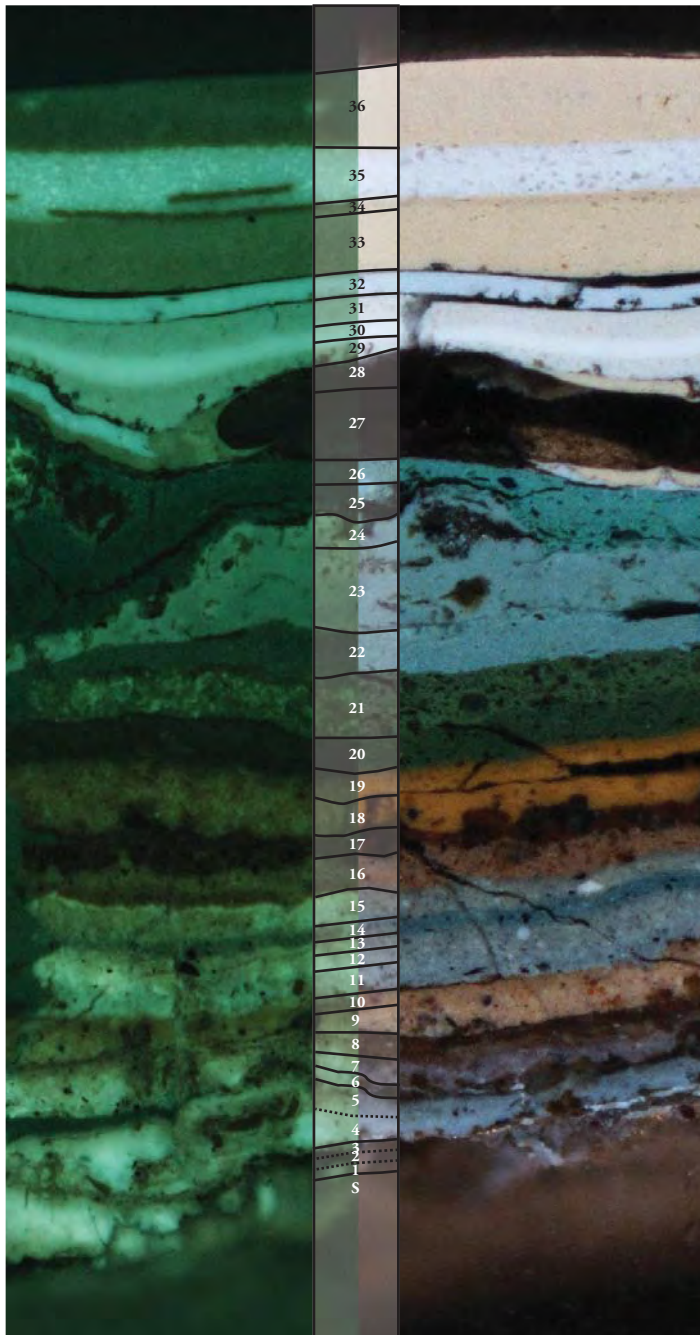
Guayama, Puerto Rico
6 E. Cecelio Dominguez Street

Sample Number: 6 :B: 4	Element: building base	Date Sampled: 02/13/11
Sample Location: middle panel		Date Analyzed: 04/09/11
Substrate: wood	Illumination: Fluorescence BV 1A, Reflected/Quartz Halogen	
Microscope: Nikon ALPHAPHOT2-YS2		Objective: 4x
Analysis Performed by: Betty Prime		Camera: Nikon DS-Fi1

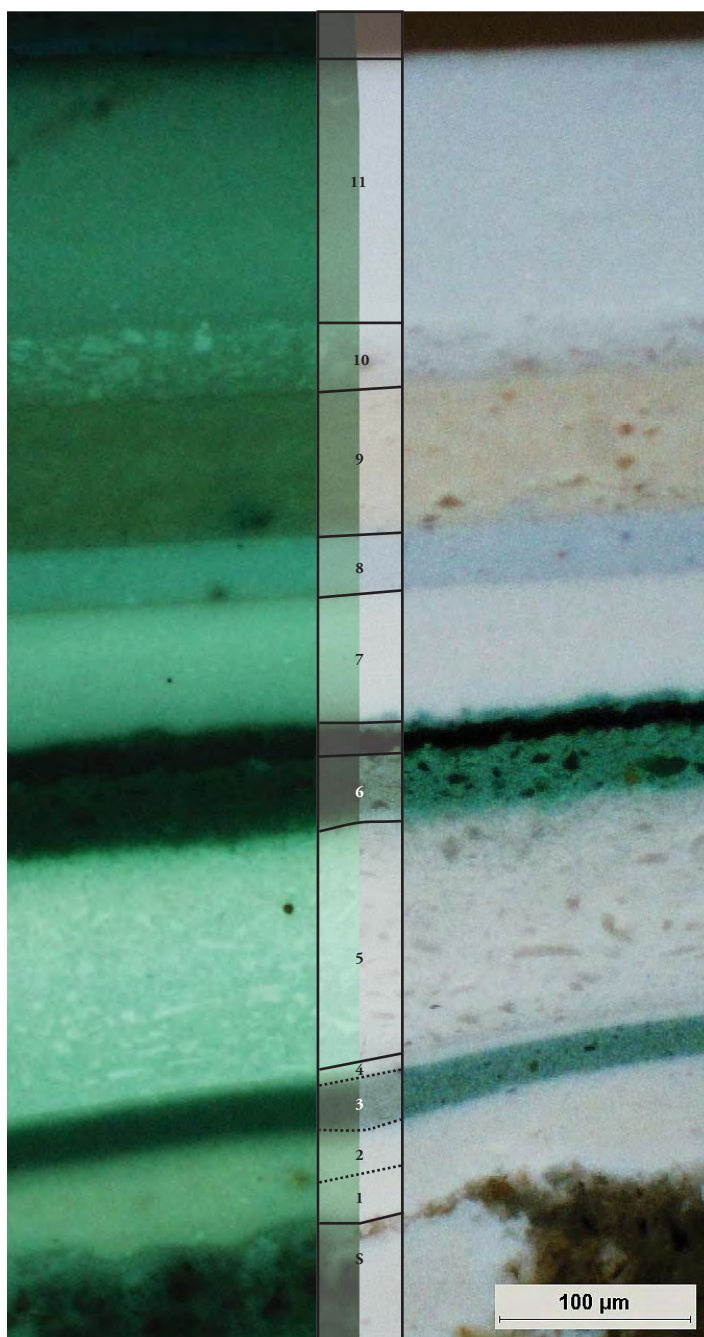
Guayama, Puerto Rico
6 E. Cecelio Dominguez Street

Sample Number: 6 :C: 2	Element: column	Date Sampled: 02/13/11
Sample Location: middle		Date Analyzed: 04/09/11
Substrate: concrete	Illumination: Fluorescence BV 1A, Reflected/Quartz Halogen	
Microscope: Nikon ALPHAPHOT2-YS2		Objective: 10x
Analysis Performed by: Betty Prime		Camera: Nikon DS-Fi1

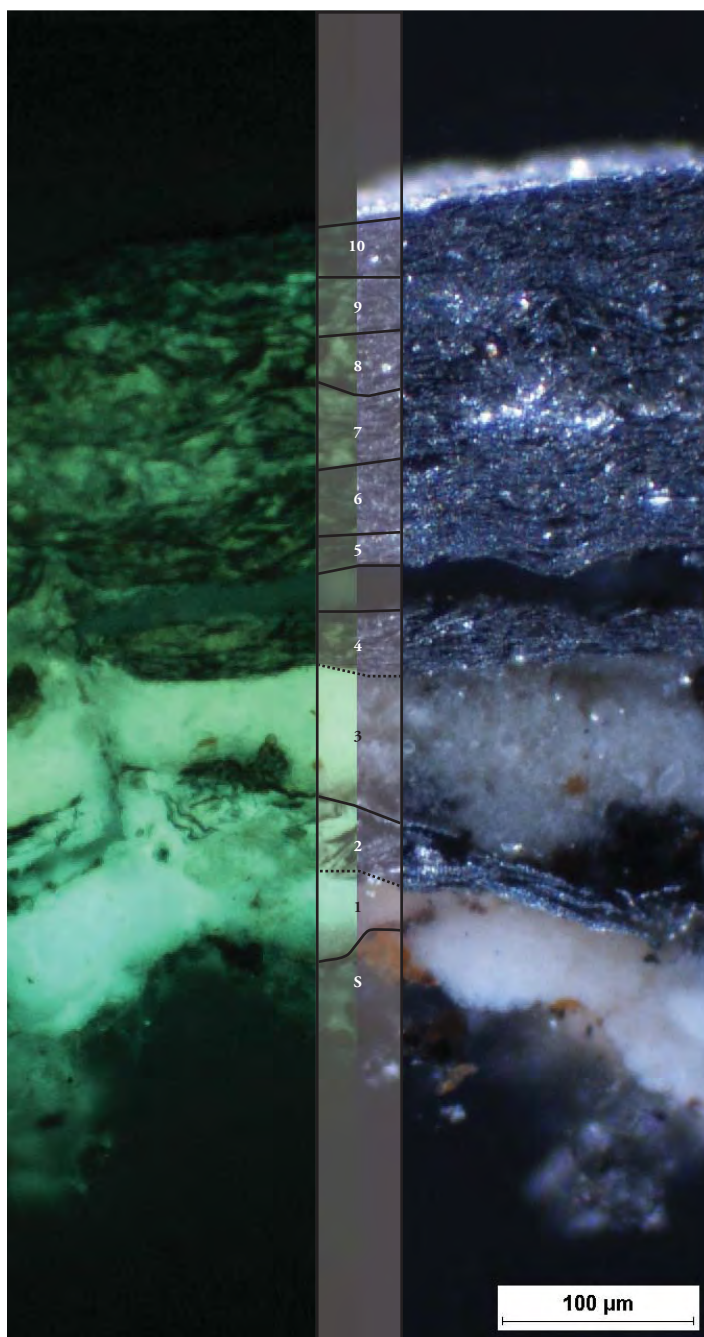
Guayama, Puerto Rico
6 E. Cecelio Dominguez Street

Sample Number: 6 :D: 1	Element: porch railing	Date Sampled: 02/13/11
Sample Location: middle		Date Analyzed: 04/09/11
Substrate: iron	Illumination: Fluorescence BV 1A, Reflected/Quartz Halogen	
Microscope: Nikon ALPHAPHOT2-YS2		Objective: 10x
Analysis Performed by: Betty Prime		Camera: Nikon DS-Fi1

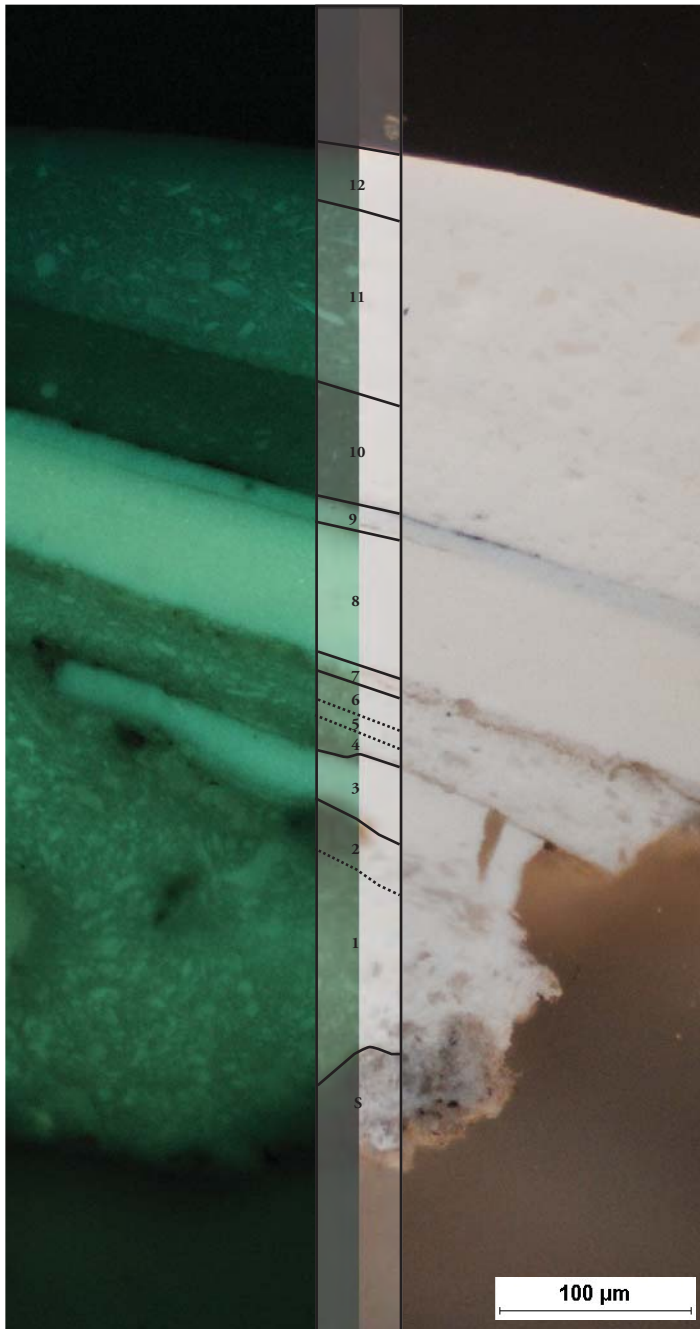
Guayama, Puerto Rico
6 E. Cecelio Dominguez Street

Sample Number: 6 :E: 1	Element: porch handrail	Date Sampled: 02/13/11
Sample Location:		Date Analyzed: 04/09/11
Substrate: concrete	Illumination: Fluorescence BV 1A, Reflected/Quartz Halogen	
Microscope: Nikon ALPHAPHOT2-YS2		Objective: 10x
Analysis Performed by: Betty Prime		Camera: Nikon DS-Fi1

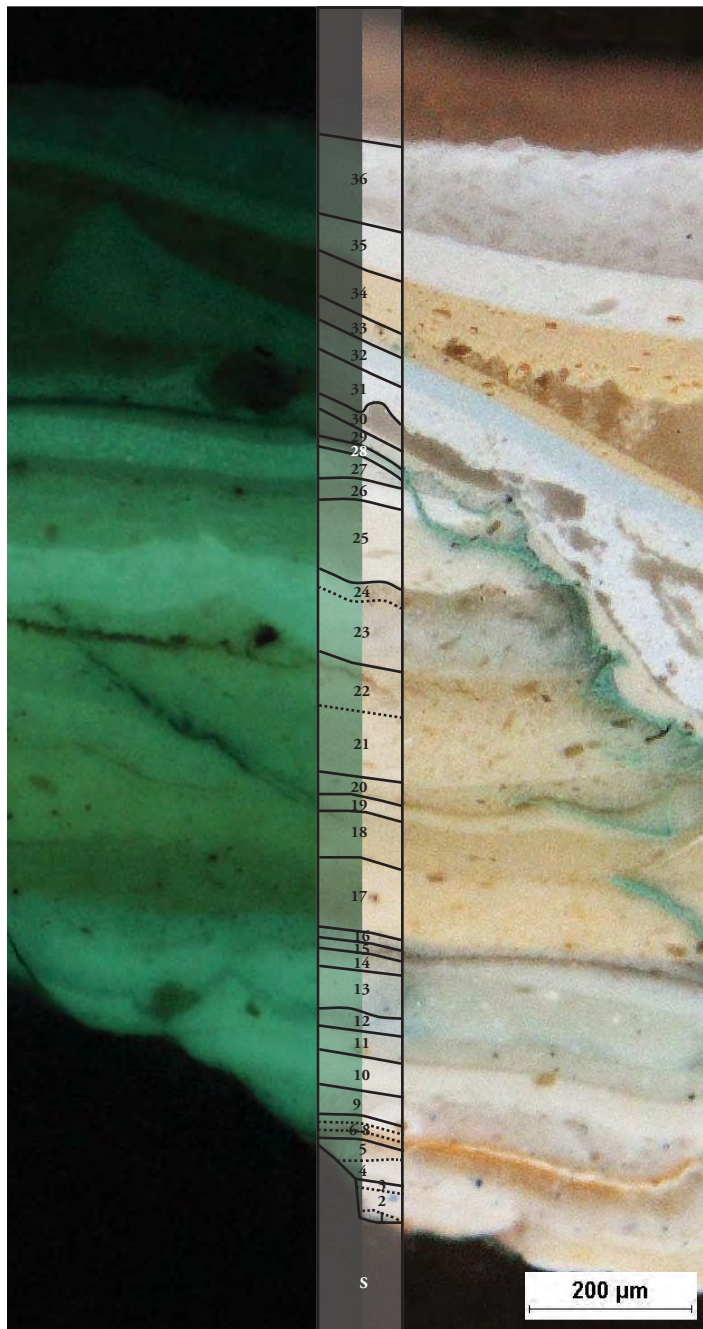
Guayama, Puerto Rico
6 E. Cecelio Dominguez Street

Sample Number: 6 :G: 1	Element: door frame	Date Sampled: 02/13/11
Sample Location: top detailing		Date Analyzed: 04/09/11
Substrate: wood	Illumination: Fluorescence BV 1A, Reflected/Quartz Halogen	
Microscope: Nikon ALPHAPHOT2-YS2		Objective: 4x
Analysis Performed by: Betty Prime		Camera: Nikon DS-Fi1

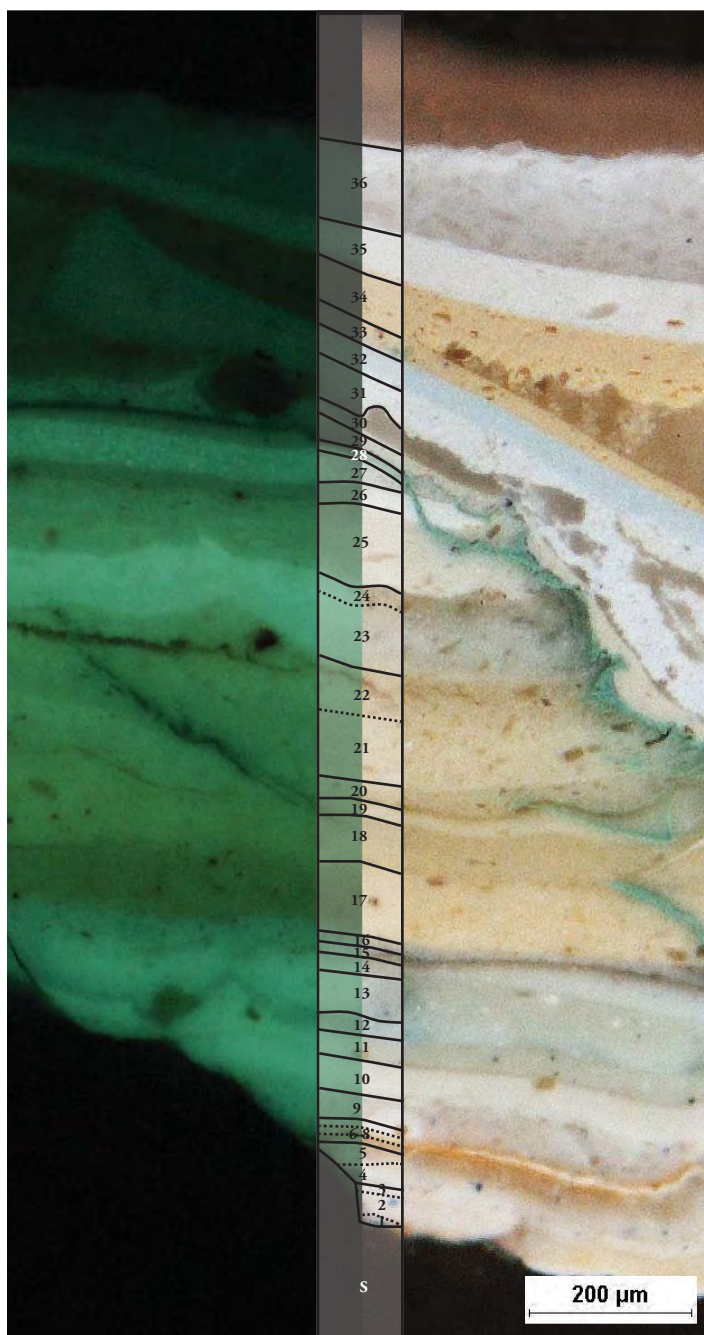
Guayama, Puerto Rico
6 E. Cecelio Dominguez Street

Sample Number: 6 :G: 1	Element: door frame	Date Sampled: 02/13/11
Sample Location: top detailing		Date Analyzed: 04/09/11
Substrate: wood	Illumination: Fluorescence BV 1A, Reflected/Quartz Halogen	
Microscope: Nikon ALPHAPHOT2-YS2		Objective: 4x
Analysis Performed by: Betty Prime		Camera: Nikon DS-Fi1

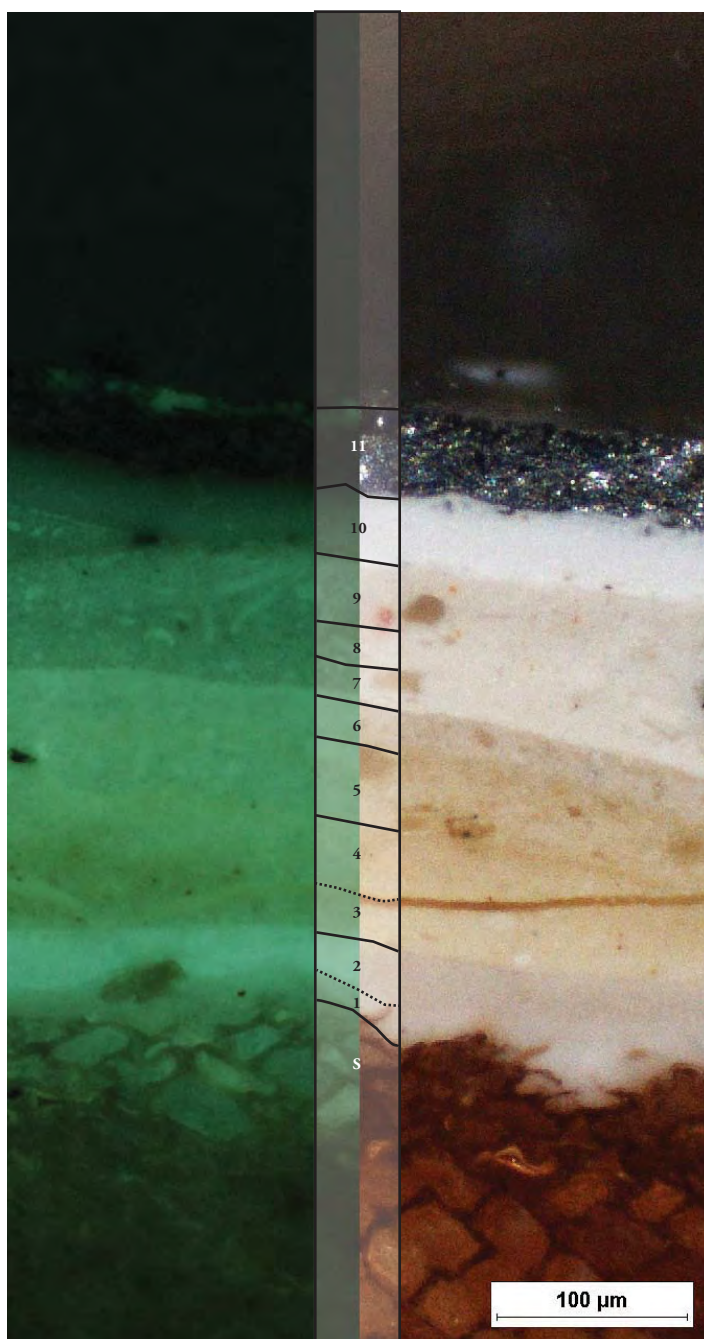
Guayama, Puerto Rico
6 E. Cecelio Dominguez Street

Sample Number: 6 :G: 2	Element: door frame	Date Sampled: 02/13/11
Sample Location: middle door, transom		Date Analyzed: 04/09/11
Substrate: wood	Illumination: Fluorescence BV 1A, Reflected/Quartz Halogen	
Microscope: Nikon ALPHAPHOT2-YS2		Objective: 10x
Analysis Performed by: Betty Prime		Camera: Nikon DS-Fi1

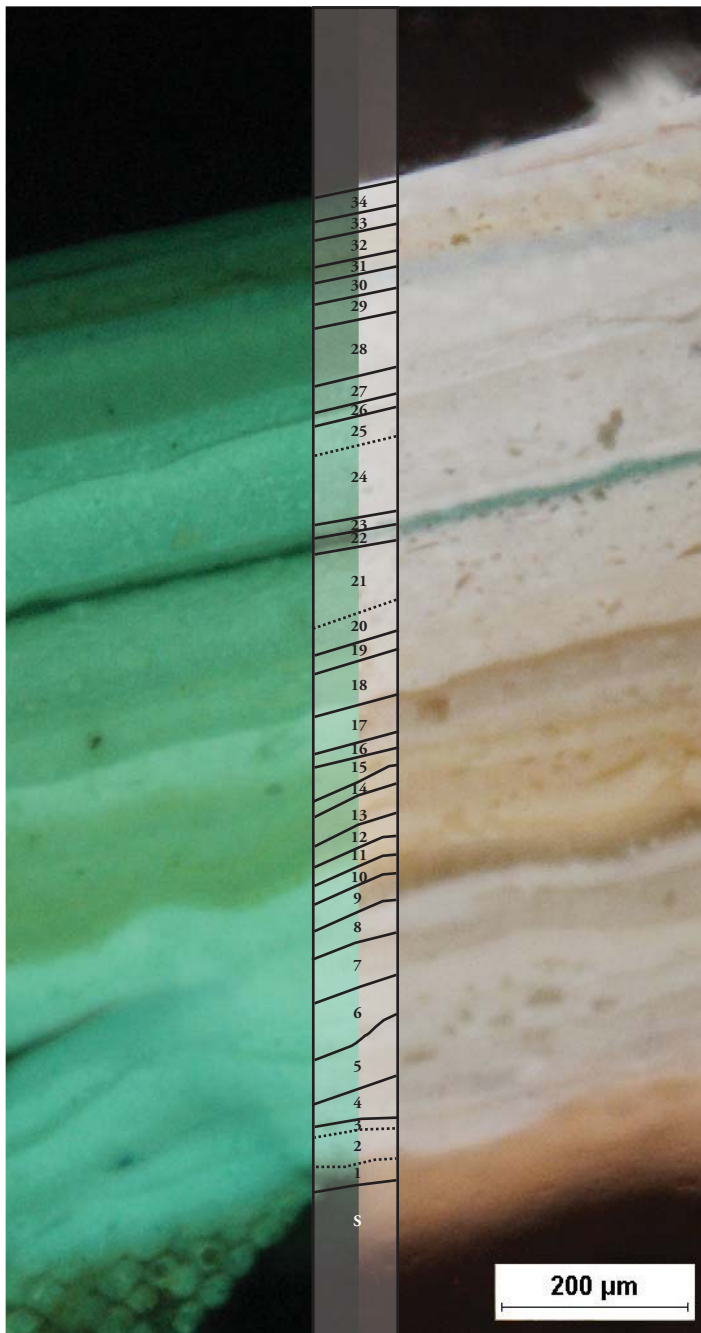
Guayama, Puerto Rico
6 E. Cecelio Dominguez Street

Sample Number: 6 :G: 3	Element: door frame	Date Sampled: 02/13/11
Sample Location: pediment, flat detail		Date Analyzed: 04/09/11
Substrate: wood	Illumination: Fluorescence BV 1A, Reflected/Quartz Halogen	
Microscope: Nikon ALPHAPHOT2-YS2		Objective: 4x
Analysis Performed by: Betty Prime		Camera: Nikon DS-Fi1

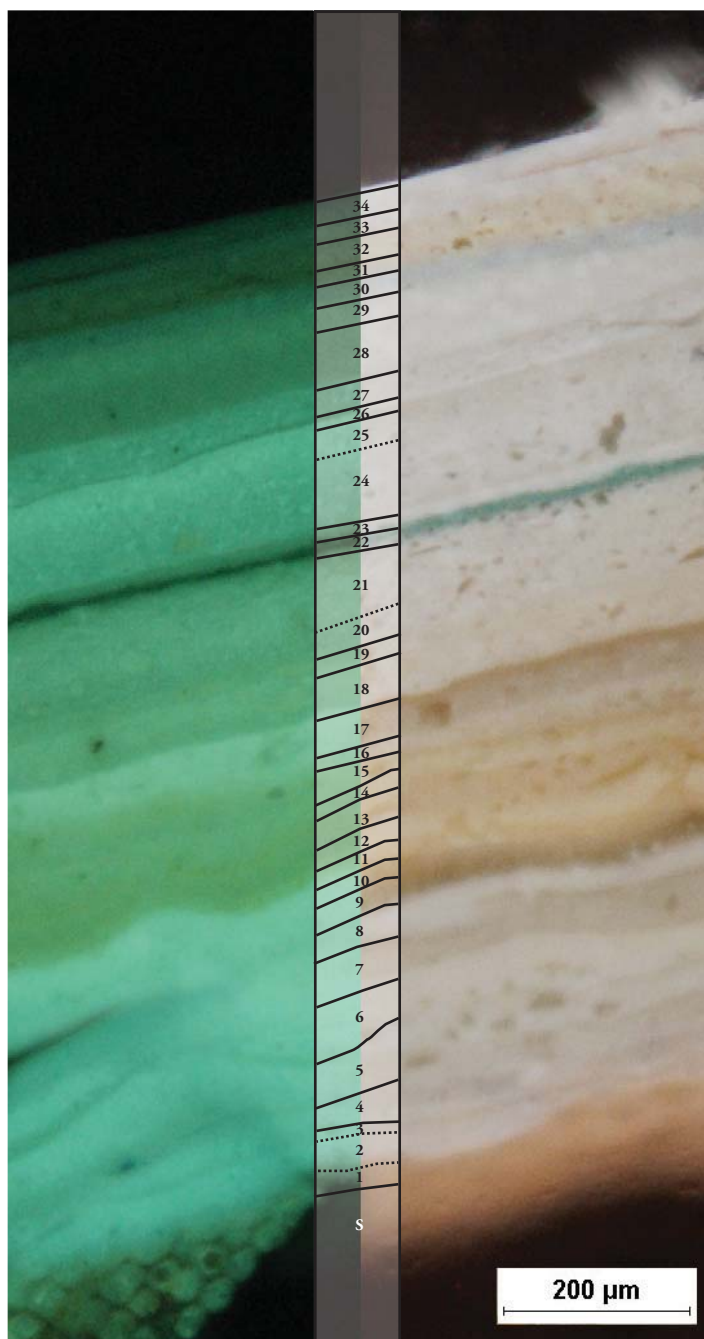
Guayama, Puerto Rico
6 E. Cecelio Dominguez Street

Sample Number: 6 :G: 3	Element: door frame	Date Sampled: 02/13/11
Sample Location: pediment, flat detail		Date Analyzed: 04/09/11
Substrate: wood	Illumination: Fluorescence BV 1A, Reflected/Quartz Halogen	
Microscope: Nikon ALPHAPHOT2-YS2		Objective: 4x
Analysis Performed by: Betty Prime		Camera: Nikon DS-Fi1

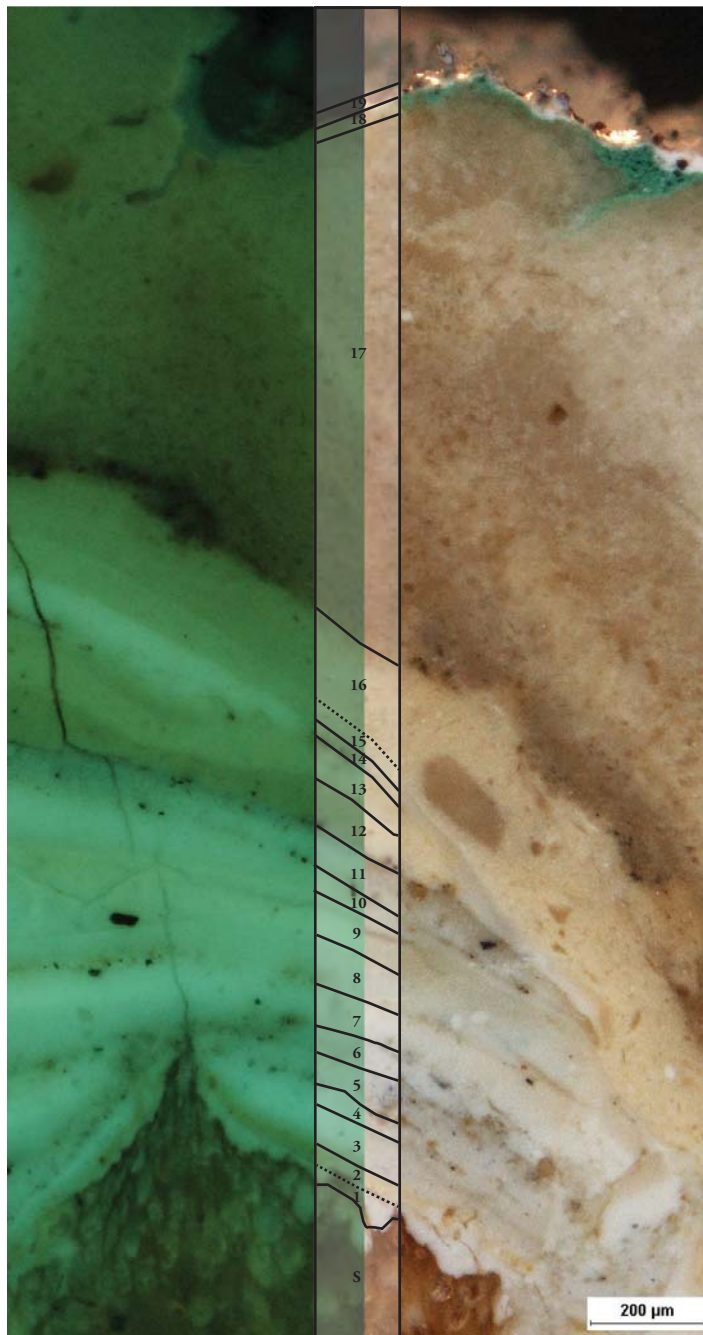
Sample Number: 6 :G: 5	Element: door frame	Date Sampled: 02/13/11
Sample Location: top of pediment main door		Date Analyzed: 04/09/11
Substrate: wood	Illumination: Fluorescence BV 1A, Reflected/Quartz Halogen	
Microscope: Nikon ALPHAPHOT2-YS2		Objective: 4x
Analysis Performed by: Betty Prime		Camera: Nikon DS-Fi1

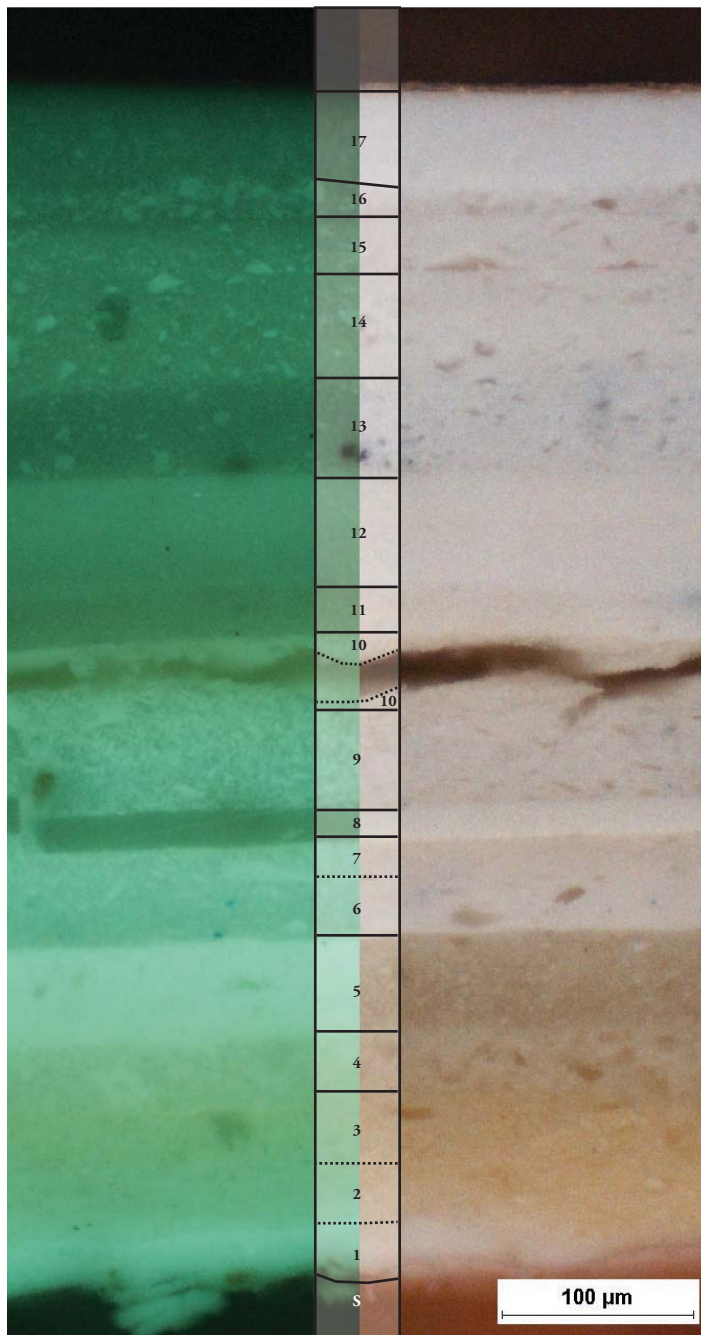
Sample Number: 6 :H: 1	Element: cornice/soffit	Date Sampled: 02/13/11
Sample Location: fascia board west		Date Analyzed: 04/09/11
Substrate: wood	Illumination: Fluorescence BV 1A, Reflected/Quartz Halogen	
Microscope: Nikon ALPHAPHOT2-YS2		Objective: 10x
Analysis Performed by: Betty Prime		Camera: Nikon DS-Fi1

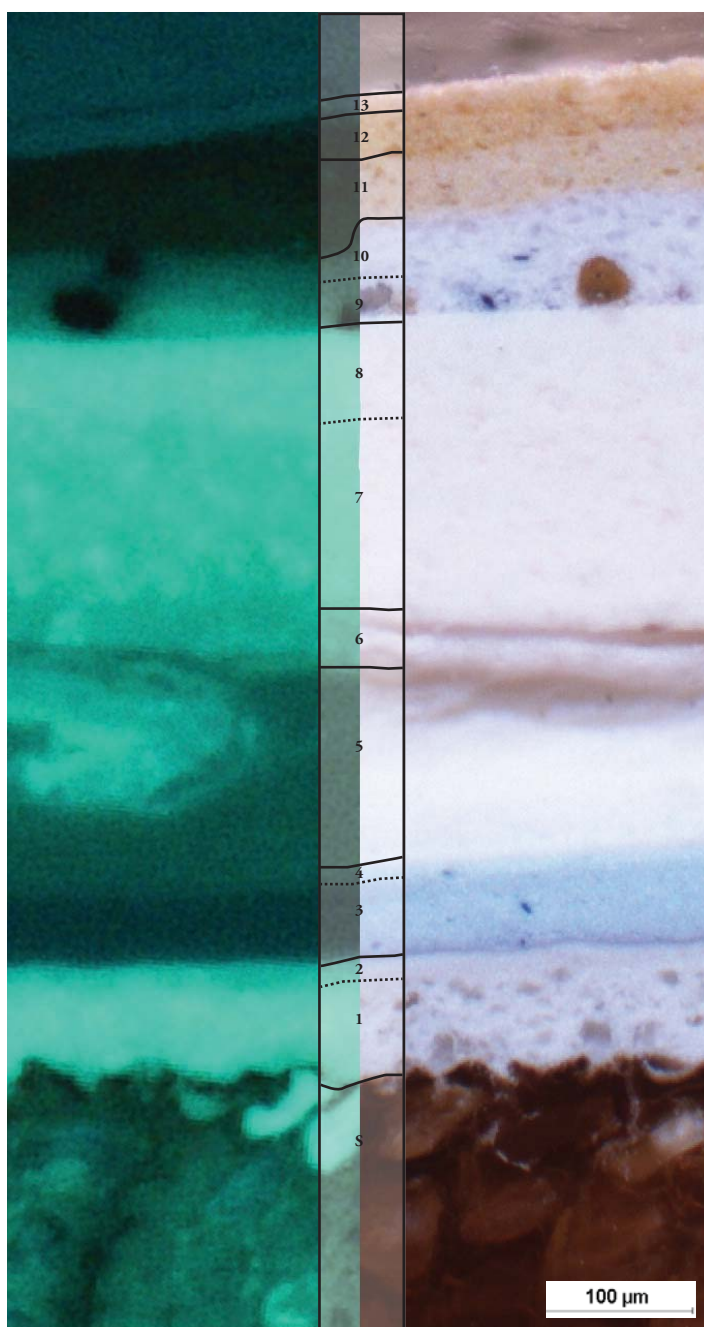
Sample Number: 43 :A: 1	Element: wall	Date Sampled: 02/13/11
Sample Location: siding above door		Date Analyzed: 03/27/11
Substrate: wood	Illumination: Reflected/Quartz Halogen	
Microscope: Nikon ALPHAPHOT2-YS2		Objective: 10x
Analysis Performed by: Betty Prime		Camera: Nikon DS-Fi1

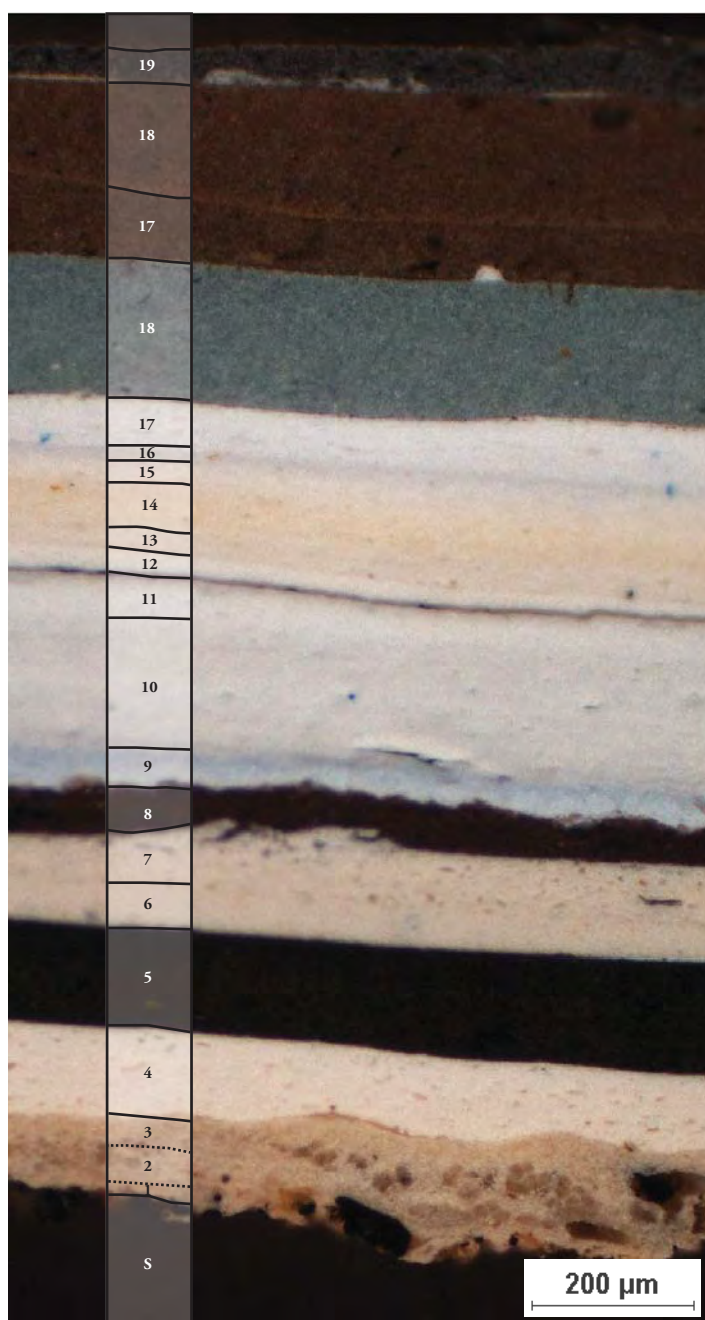
Sample Number: 43 :A: 3	Element: wall	Date Sampled: 02/13/11
Sample Location: baseboard		Date Analyzed: 03/27/11
Substrate: wood	Illumination: Reflected/Quartz Halogen	
Microscope: Nikon ALPHAPHOT2-YS2		Objective: 4x
Analysis Performed by: Betty Prime		Camera: Nikon DS-Fi1

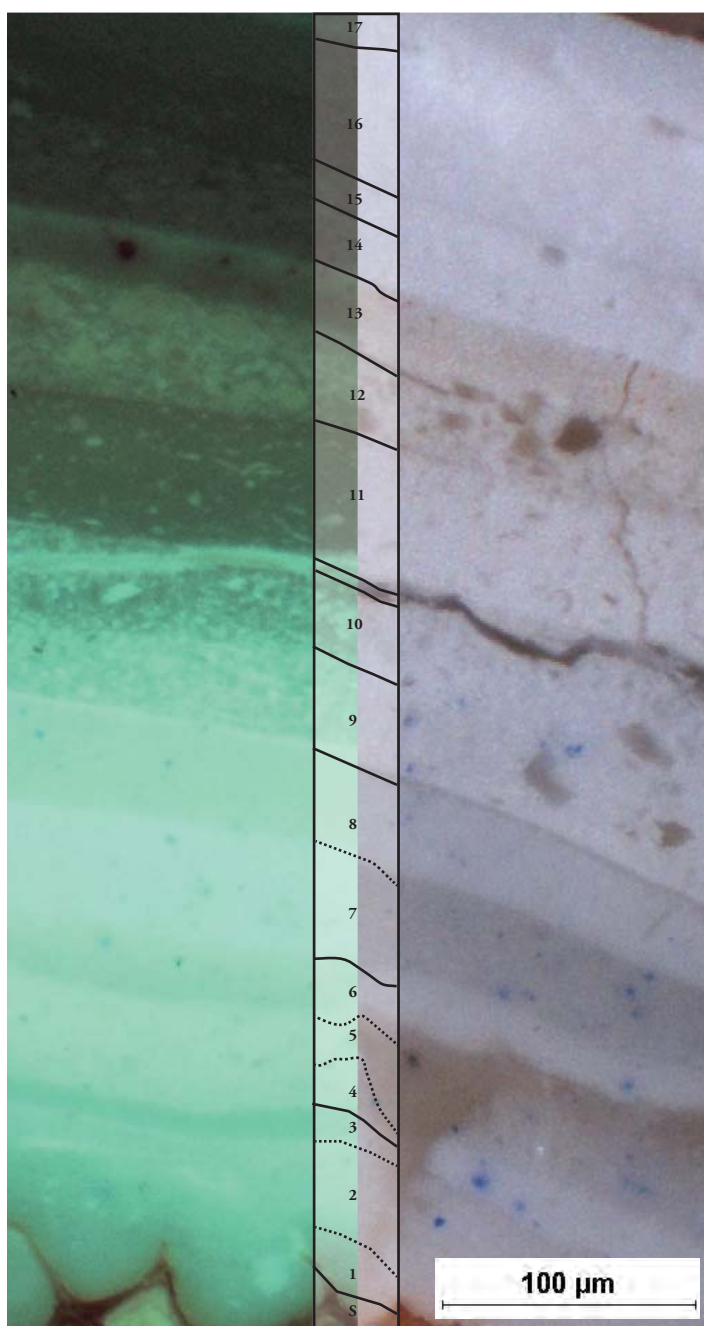
Sample Number: 43 :A: 5	Element: wall	Date Sampled: 02/13/11
Sample Location: trim, crown moulding above south door		Date Analyzed: 03/27/11
Substrate: wood	Illumination: Fluorescence BV 1A, Reflected/Quartz Halogen	
Microscope: Nikon ALPHAPHOT2-YS2		Objective: 10x
Analysis Performed by: Betty Prime		Camera: Nikon DS-Fi1

Scheme/Layer		Color
12	17	white
11	16	white
10	15	*white
9	14	white
8	13	cream
7	12	/white cream
6	11	off white
5	10	/blue white
4	9	blue white
3	8	/blue white
	7	blue white
2	6	blue white
	5	blue white
	4	blue white
1	3	blue white
	2	blue white
	1	blue white
		substrate

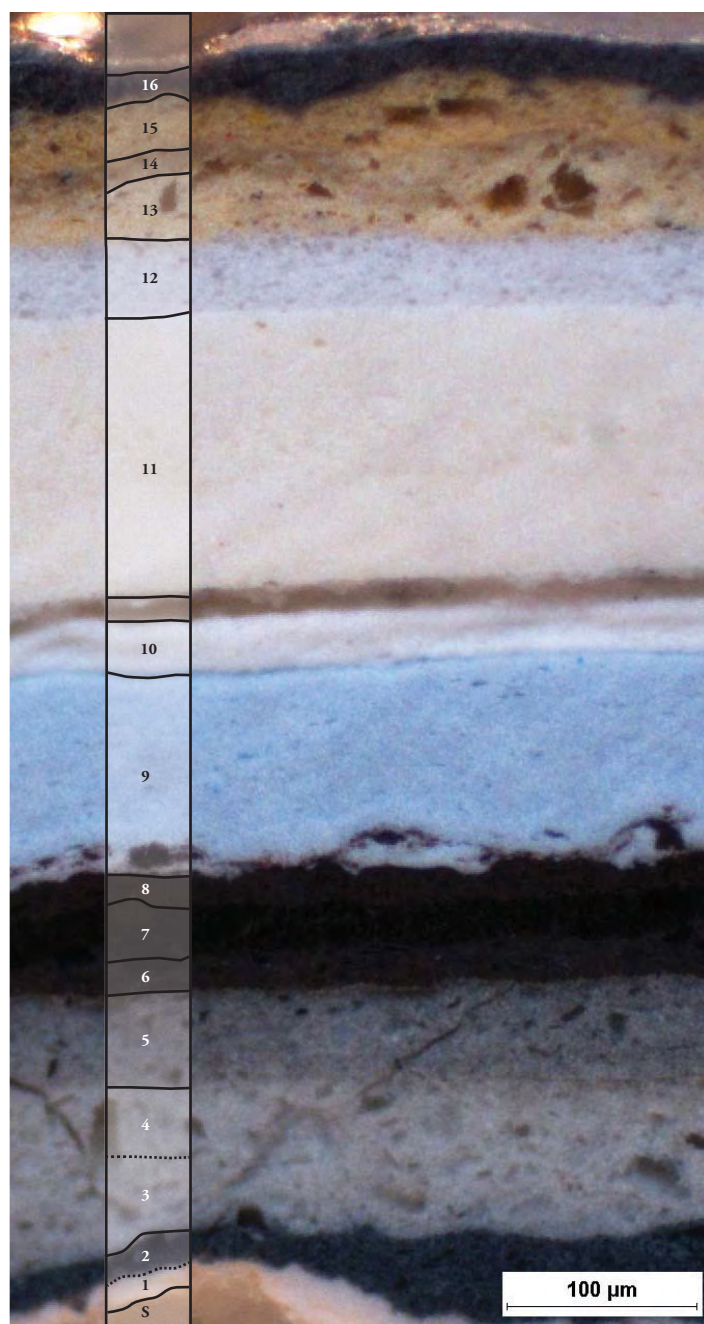
Sample Number: 43 :B: 1	Element: building base	Date Sampled: 02/13/11
Sample Location: central panel		Date Analyzed: 03/27/11
Substrate: concrete	Illumination: Reflected/Quartz Halogen	
Microscope: Nikon ALPHAPHOT2-YS2		Objective: 10x
Analysis Performed by: Betty Prime		Camera: Nikon DS-Fi1

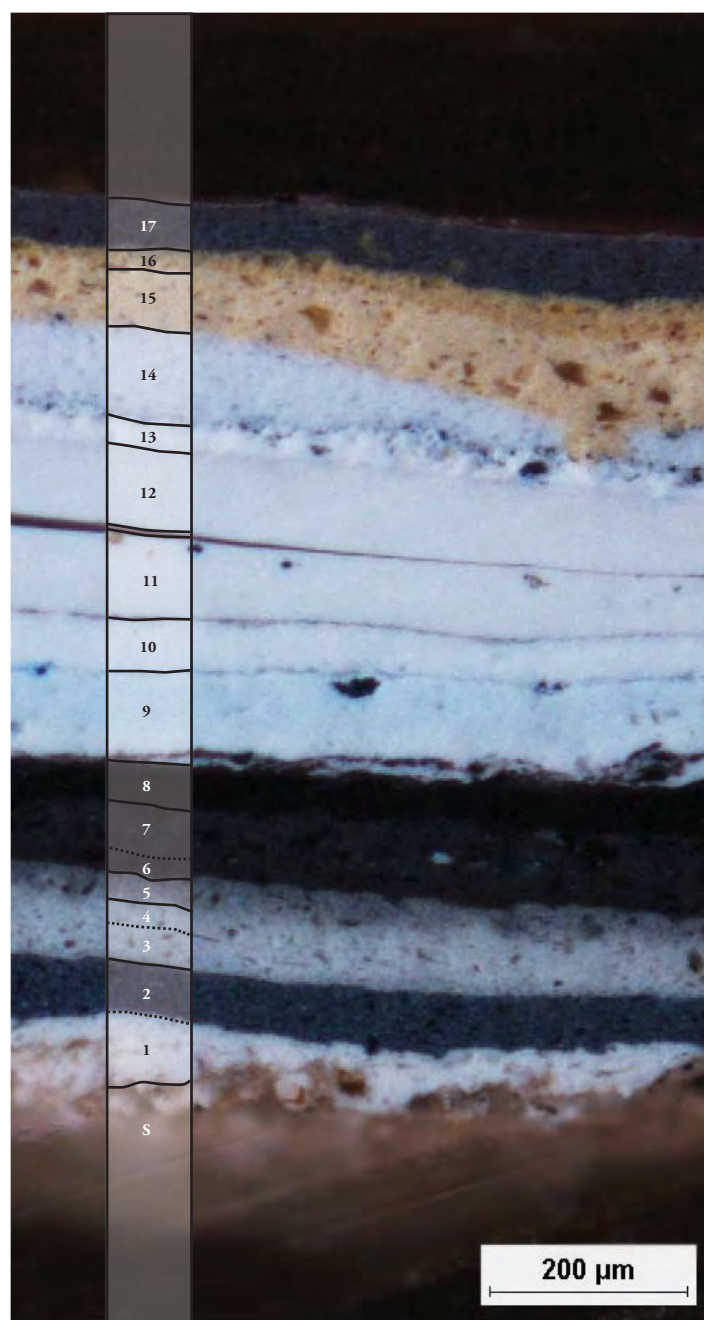
Sample Number: 43 :B: 2	Element: building base	Date Sampled: 02/13/11
Sample Location: dividers below columns		Date Analyzed: 03/27/11
Substrate: concrete	Illumination: Reflected/Quartz Halogen	
Microscope: Nikon ALPHAPHOT2-YS2		Objective: 4x
Analysis Performed by: Betty Prime		Camera: Nikon DS-Fi1

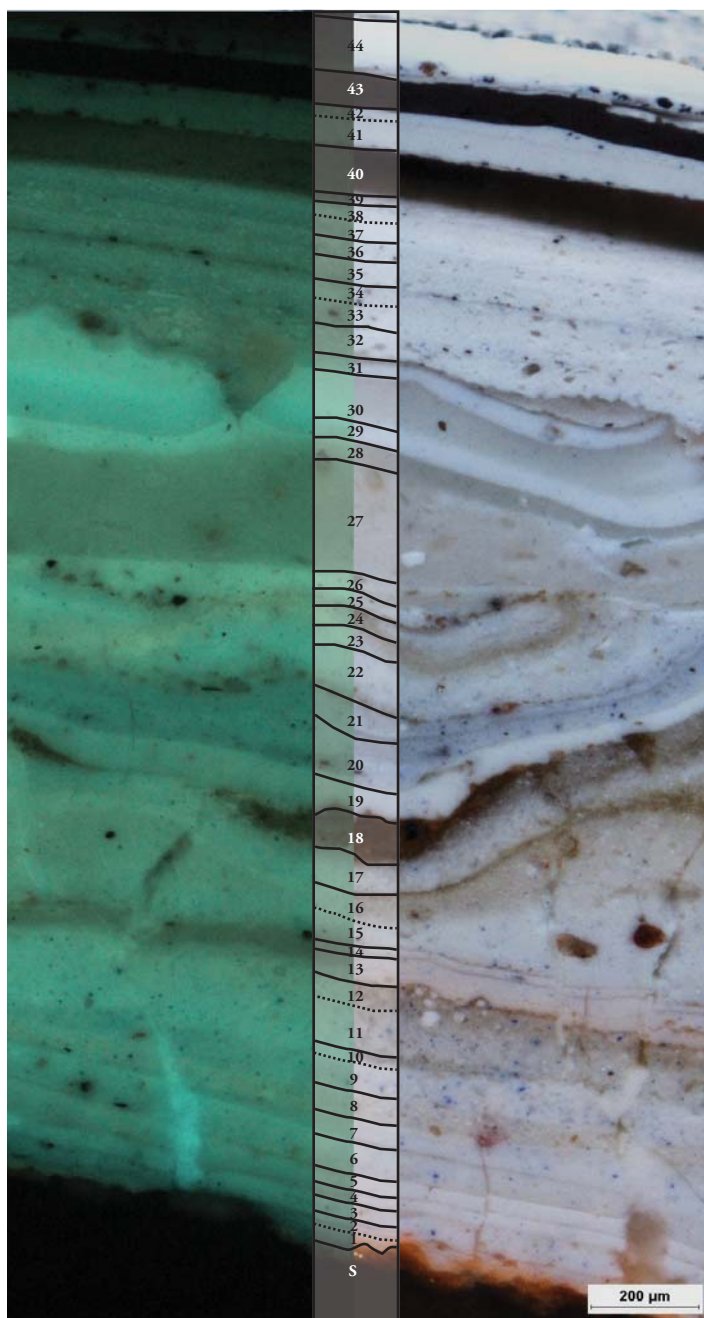
Sample Number: 43 :C: 3	Element: column	Date Sampled: 02/13/11
Sample Location: capital		Date Analyzed: 03/27/11
Substrate: wood	Illumination: Fluorescence BV 1A, Reflected/Quartz Halogen	
Microscope: Nikon ALPHAPHOT2-YS2	Objective: 4x	
Analysis Performed by: Betty Prime	Camera: Nikon DS-Fi1

Scheme/Layer		Color
21	25	blue white
20	24	*blue white
19	23	tan
18	22	blue white
17	21	*light blue
16	20	*light blue
15	19	*white
14	18	tan
13	17	blue white
12	16	*off white
11	15	blue white
10	14	*pink white
9	13	*pink white
8	12	*blue white
7	11	blue white
6	10	blue white
5	9	blue white
4	8	off white
3	7	blue white
2	6	*blue white
1	5	*white
	4	*white
	3	*blue white
	2	/*off white
	1	white
		substrate

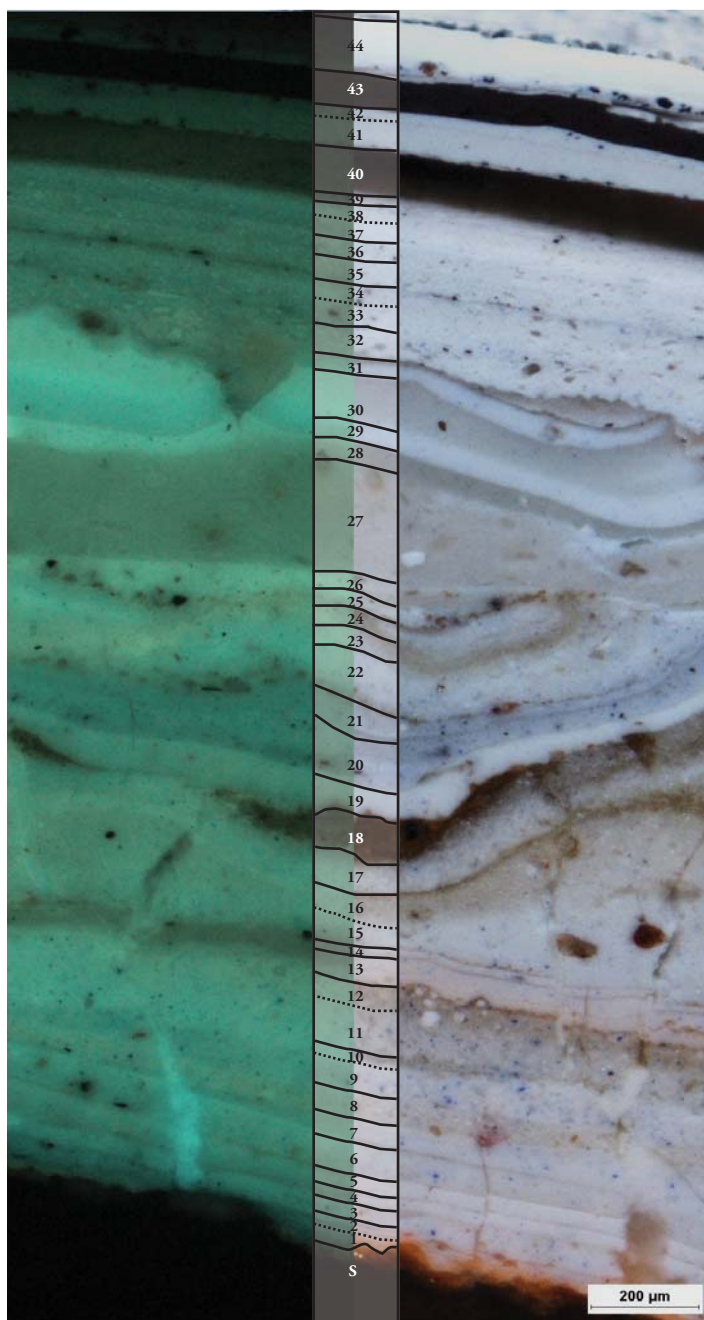
Sample Number: 43 :C: 3	Element: column	Date Sampled: 02/13/11
Sample Location: capital		Date Analyzed: 03/27/11
Substrate: wood	Illumination: Fluorescence BV 1A, Reflected/Quartz Halogen	
Microscope: Nikon ALPHAPHOT2-YS2		Objective: 4x
Analysis Performed by: Betty Prime		Camera: Nikon DS-Fi1

Scheme/Layer		Color
36	43	*white
35	42	*/dark brown
	41	white
34	40	white
33	39	/white
32	38	off white
31	37	off white
	36	off white
30	35	off white
29	34	*off white
28	33	off white
	32	off white
27	31	blue white
26	30	blue white
25	29	blue tan
24	28	blue white
23	27	blue tan
22	26	off white
